MARINE INVESTIGATION REPORT
M01C0008

STRIKING OF THE TANKER *HAMILTON ENERGY*
AND
STRIKING AND SINKING
OF THE TANKER *PROVMAR TERMINAL*

BY THE BULK CARGO *UTVIKEN*
NEAR PIER 23, HAMILTON HARBOUR, ONTARIO
01 APRIL 2001

Report Number M01C0008

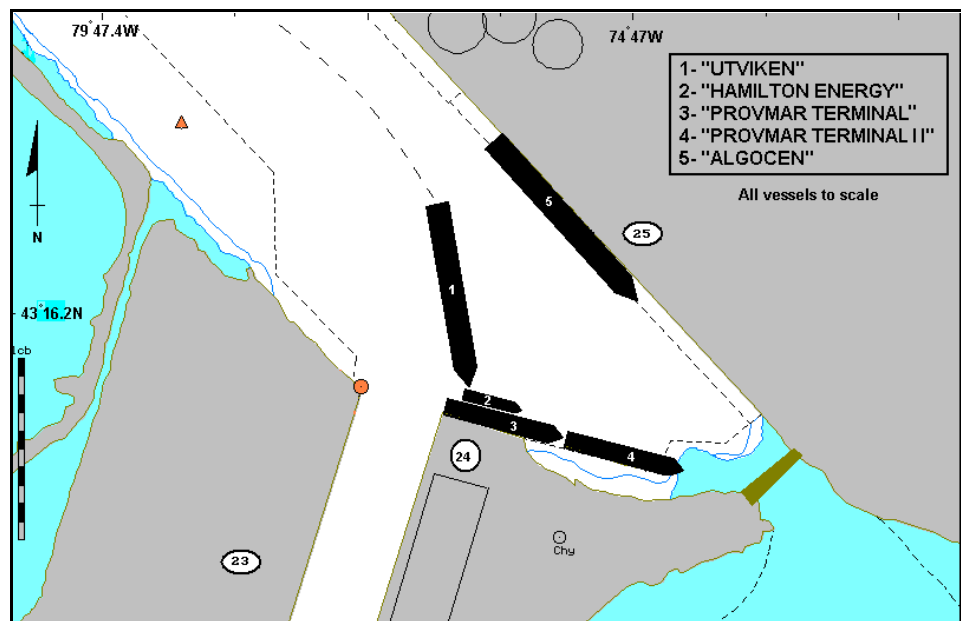
Figure 1. Pier 23 Area.

the arrival of *Utviken*. Arrangements were made to pass the *Lake Superior*, starboard to starboard, near section 27. The manoeuvring room opposite the entrance to Pier 23 was reduced by the presence of the bulk cargo *Algocen* berthed at section 25.
